# **INDOOR AIR QUALITY ASSESSMENT**

**Joseph Estabrook School  
117 Grove Street  
Lexington, MA 02420**

Prepared by:  
Massachusetts Department of Public Health  
Center for Environmental Health  
Emergency Response/Indoor Air Quality Program  
February 2006

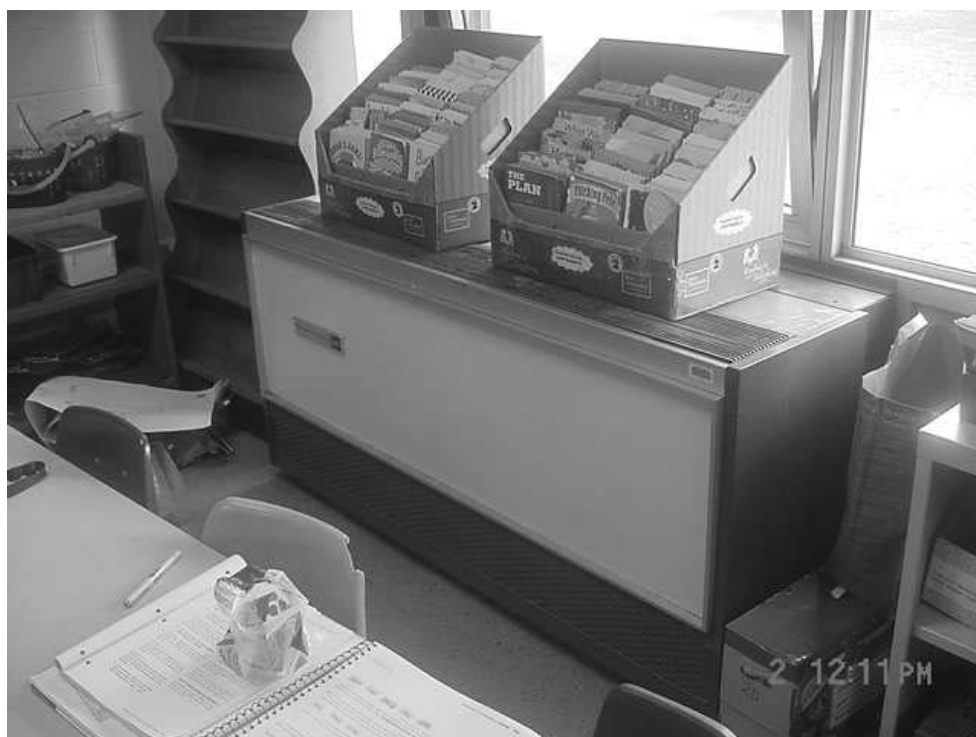
**Picture 1**

As mentioned, fresh air in the majority of classrooms is supplied by a unit ventilator (univent) system (Picture 1). A univent draws air from outdoors through a fresh air intake located on the exterior wall of the building (Picture 2) and returns air through an air intake located at the base of the unit ([Figure 1](#)). Fresh and return air are mixed, filtered, heated and provided to classrooms through an air diffuser located in the top of the unit. Univents are equipped with control settings of low, medium or high (Picture 3). Although the majority of univents were inoperable at the time of the assessment, those that were operable were deactivated. Obstructions to airflow, such as papers and books stored on univents and items in front of univent returns were seen in a number of classrooms (Pictures 1, 4 and 5). In order for univents to provide fresh air as designed, air diffusers and return vents must remain free of obstructions. Importantly, these units must remain “on” and allowed to operate while rooms are occupied.

**Classroom Univent, Note Items on Top of Air Diffuser**

6. Remove all blockages in classrooms from univents and exhaust vents to ensure adequate airflow.
7. Install a passive vent in the door of hallway offices/special education rooms to provide air exchange.

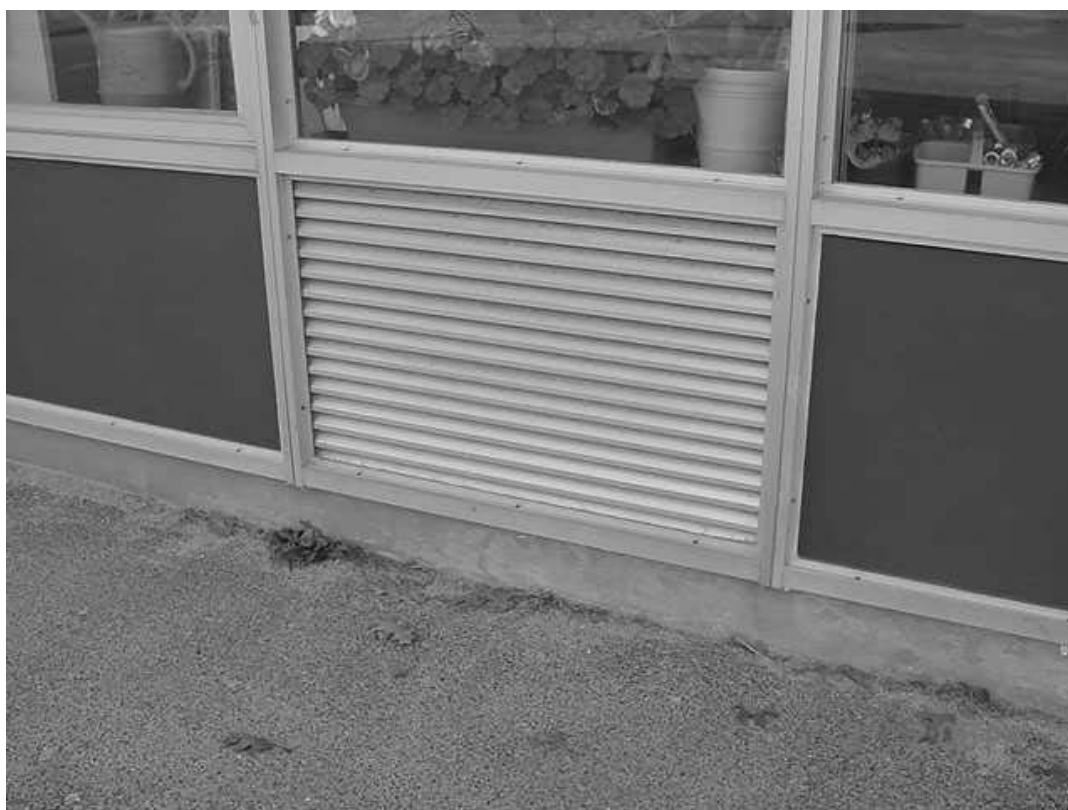
**Picture 2**

**Univent Fresh Air intake**

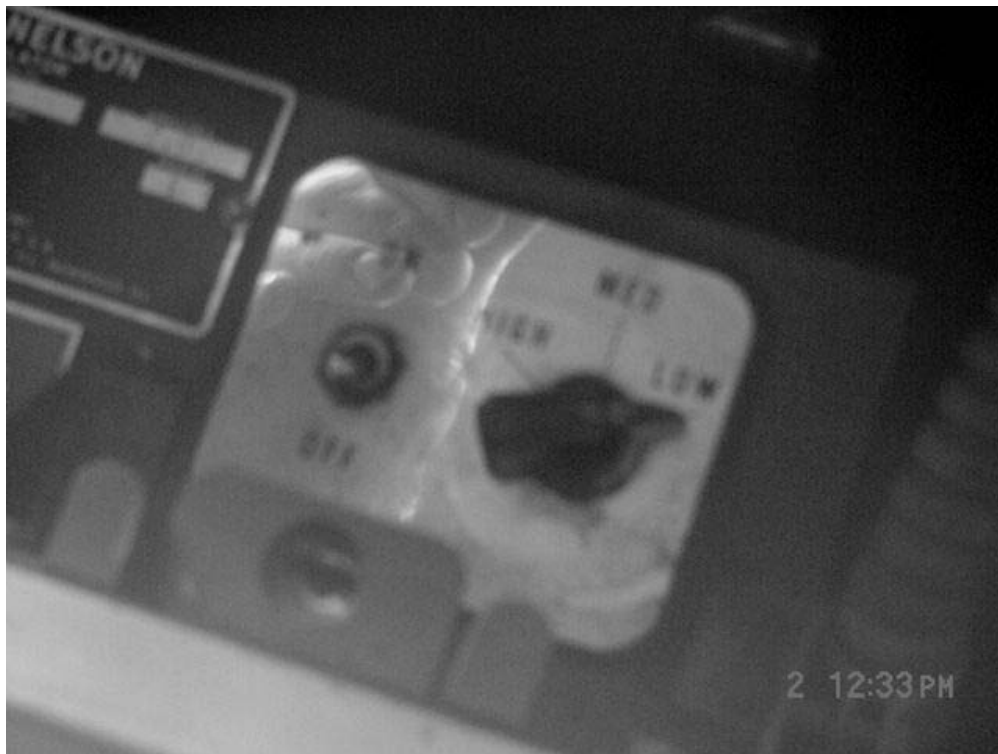
**Picture 3**

**Univent Control Settings, Note Unit is Deactivated Via the Toggle Switch**

1. Continue with plans to make repairs to mechanical heating and ventilation equipment building wide.
2. Once repairs are made operate all functional ventilation systems throughout the building (e.g., gym, cafeteria, classrooms) continuously during periods of school occupancy and independent of thermostat control. To increase airflow in classrooms, set univent controls to “high”.

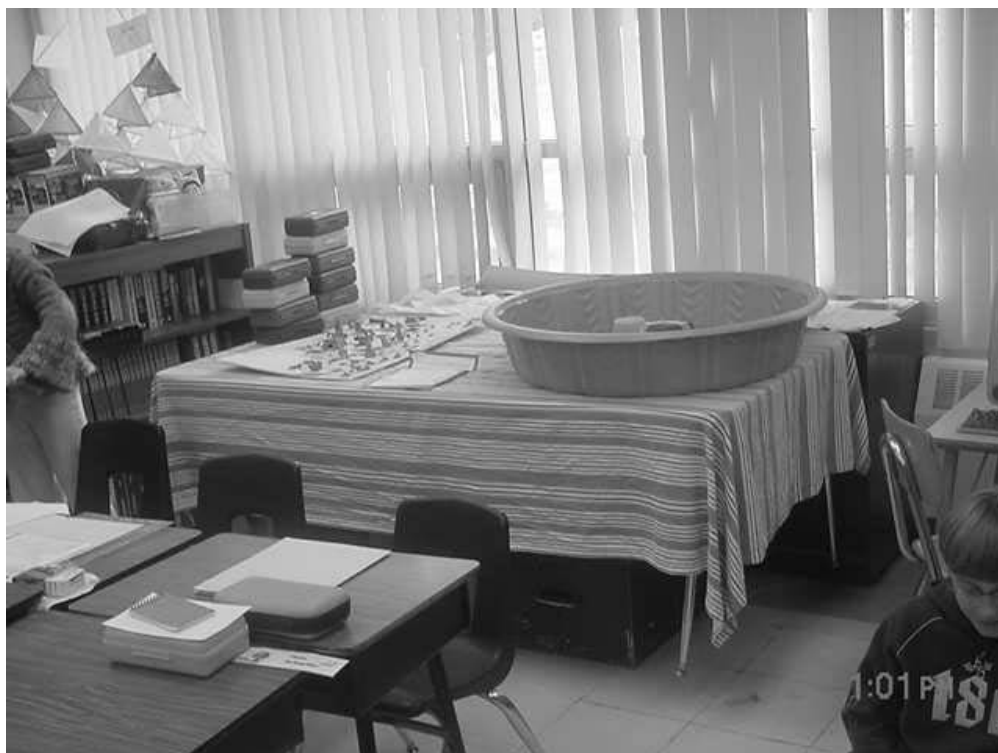
**Picture 4**

**Table and File Cabinets in Front of Univent Obstructing Return Vent  
(along bottom front of unit)**

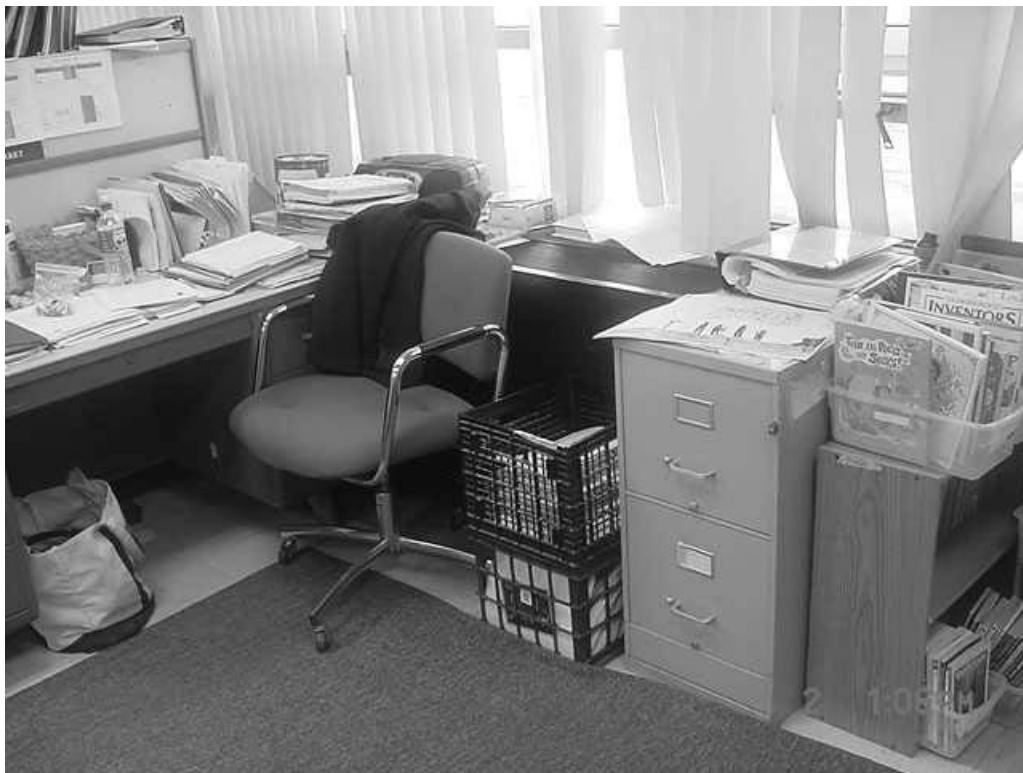
**Picture 5**

**Items on and in Front of Univent Obstructing Airflow**

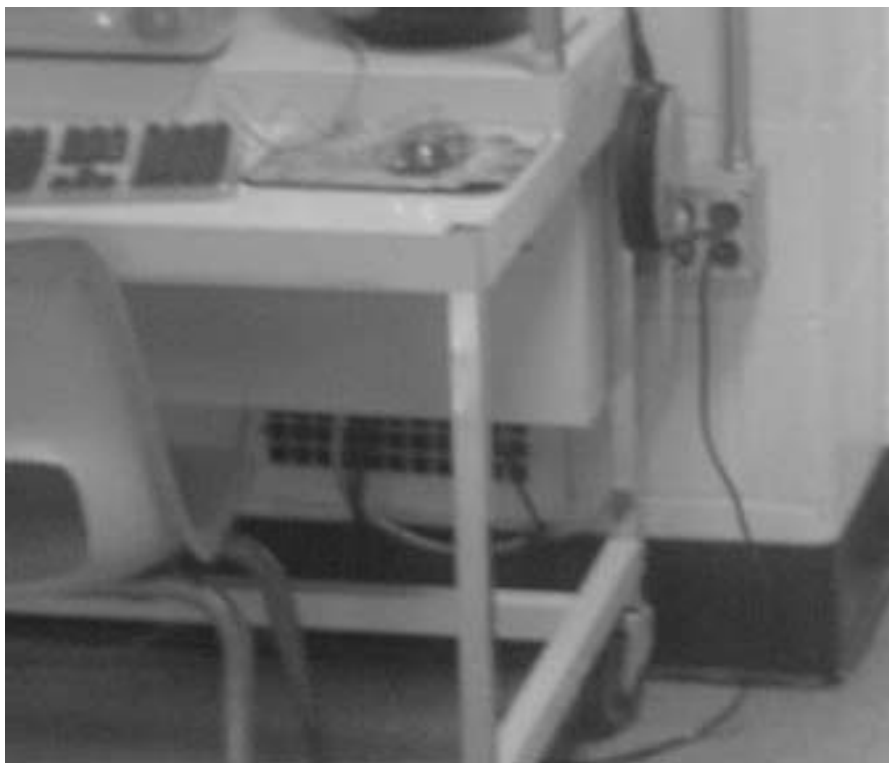
**Picture 6**

Exhaust ventilation is provided by grated wall vents ducted to rooftop motors. As with the univents, these vents were not drawing air and/or were obstructed in several areas (Picture 6/Table 1). Exhaust vents must be activated and remain free of obstructions to function as designed.

**Classroom Exhaust Vent Obstructed by Computer Table**

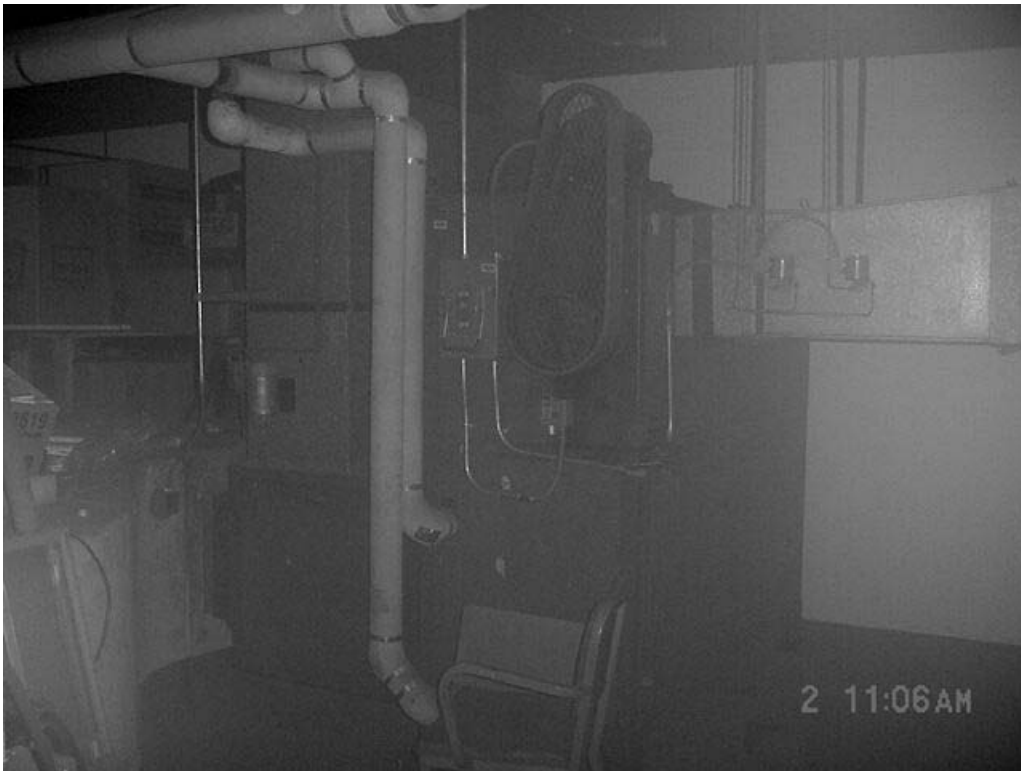
**Picture 7**

Mechanical ventilation in classrooms 6 and 20 is provided by an air handling unit (AHU) located in the basement (Picture 7). Fresh air is drawn through an outside air intake, heated, filtered and distributed to classrooms via ceiling-mounted air diffusers (Picture 8). Return air is drawn into grated wall vents back to the AHU (Picture 8). The AHU was not operating during the assessment. Mechanical ventilation for the gym is provided by AHUs in mechanical rooms.

**Air Handling Unit in Basement**

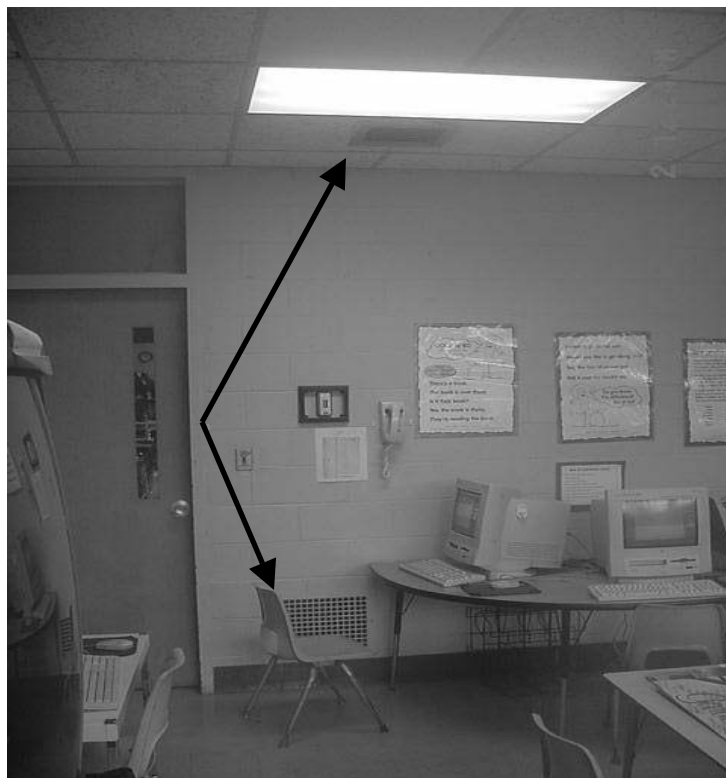
**Picture 8**

**Ceiling-Mounted Air Diffuser and Wall-Mounted Return Vent (Classrooms 6 and 20)**

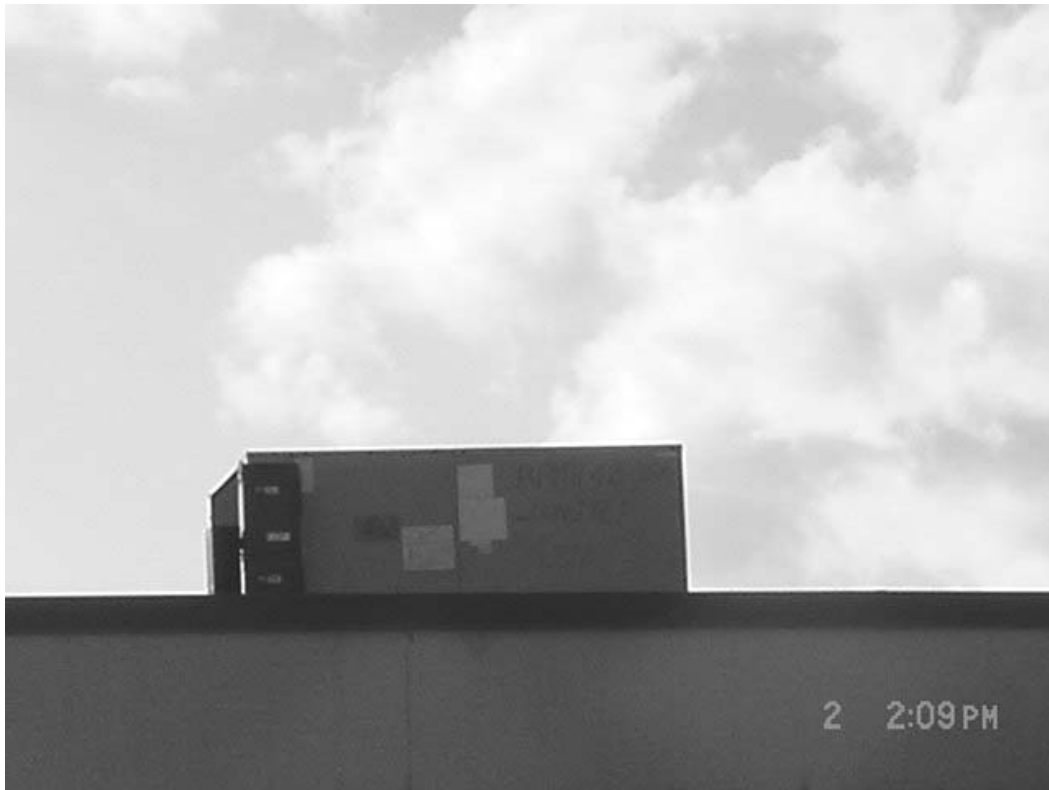
**Picture 9**

Ventilation for modular classrooms is provided by rooftop AHUs (Picture 9). Fresh air is distributed to classrooms via ductwork connected to ceiling-mounted air diffusers. Return vents draw air back to the units through ceiling-mounted grilles. Thermostats control each heating, ventilating and air conditioning (HVAC) system and have fan settings of “on” and “automatic”. Thermostats were set to the “automatic” setting (Picture 10) in all of the modular rooms surveyed during the assessment. The automatic setting on the thermostat activates the HVAC system at a preset temperature. Once the preset temperature is reached, the HVAC system is deactivated. Therefore, no mechanical ventilation is provided until the thermostat re-activates the system.

**Rooftop AHU for Modular Classroom**

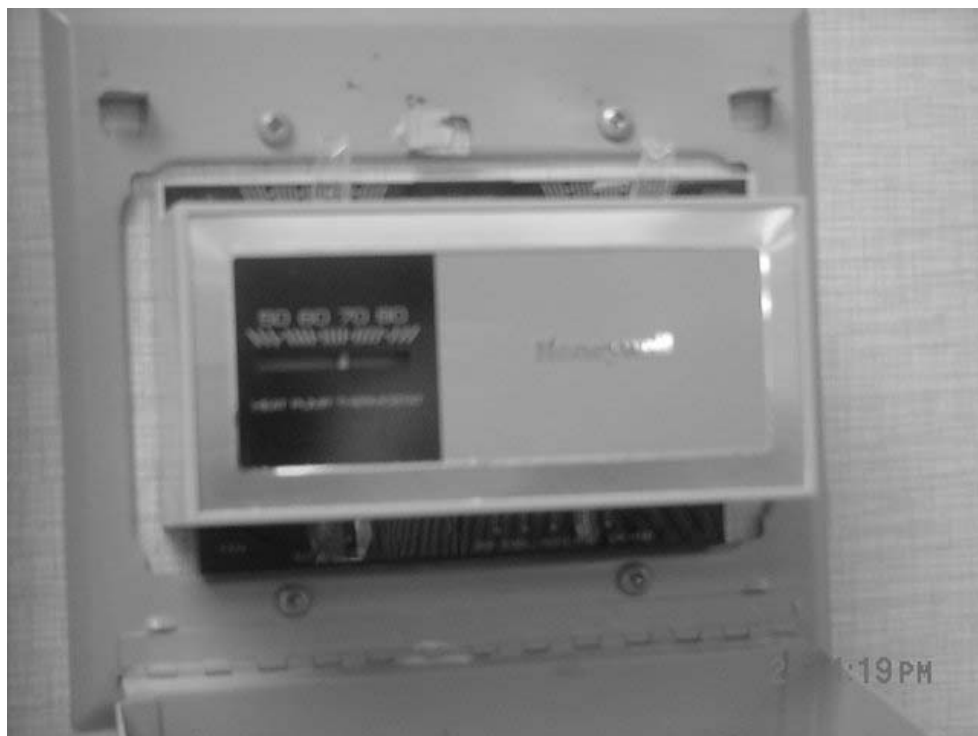
**Picture 10**

**Thermostat for Modular Classroom**

4. Set thermostats for modular classrooms to the fan “on” position to operate the ventilation system continuously during the school day.
5. Inspect exhaust motors and belts for proper function. Repair and replace as necessary.

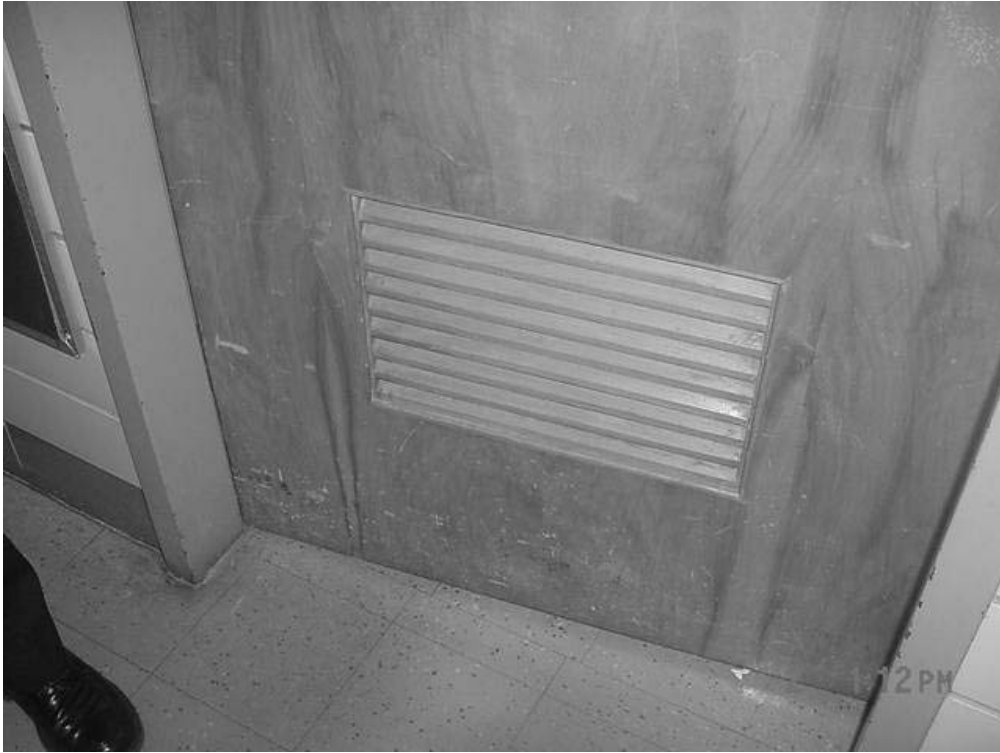
**Picture 11**

A series of small offices/special education rooms were constructed in the hallway. The offices are equipped with wall-mounted exhaust vents but have no provision for supply air. It is recommended that passive door vents be installed to provide make up air (Picture 11).

**Example of Passive Vent Recommended for Small Offices/Special Learning Areas Constructed in Hallway (e.g., Ms. Zendeh's Room)**

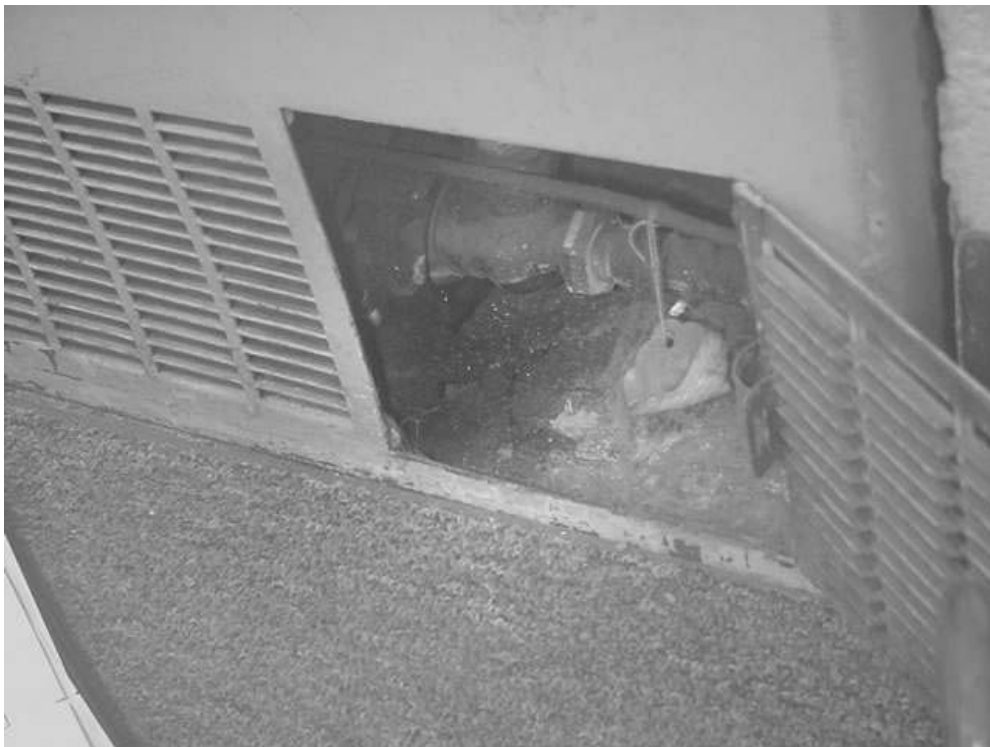
**Picture 12**

Steam leaks from heating pipes were noted in rooms 3, 20 and 22. In classroom 3 the carpeting around the univent was wet. JES staff was aware of the leak in classroom 3, and deactivated the univent at the time of assessment. CEH staff recommended that the carpeting be dried with fans. In classrooms 20 and 22, the leaks were inside a radiator (Picture 12) and a univent, respectively. These leaks were reported to Mr. Hartigan during the assessment. MDPH staff recommended that once repairs were made, the carpeting in classroom 3 be dried (e.g., fans

and/or heating) and the interior of the radiator casing in classroom 20 and univent in classroom 22 be cleaned and dried to prevent microbial growth.

**Steam Leak inside Radiator Unit in Classroom 20**

10. Ensure steam leaks are repaired in heating system. Inspect carpeting and other porous materials in these areas (classrooms 3, 20 and 22) for mold growth. If moldy, replace affected materials, clean and disinfect non-porous materials with an appropriate antimicrobial.

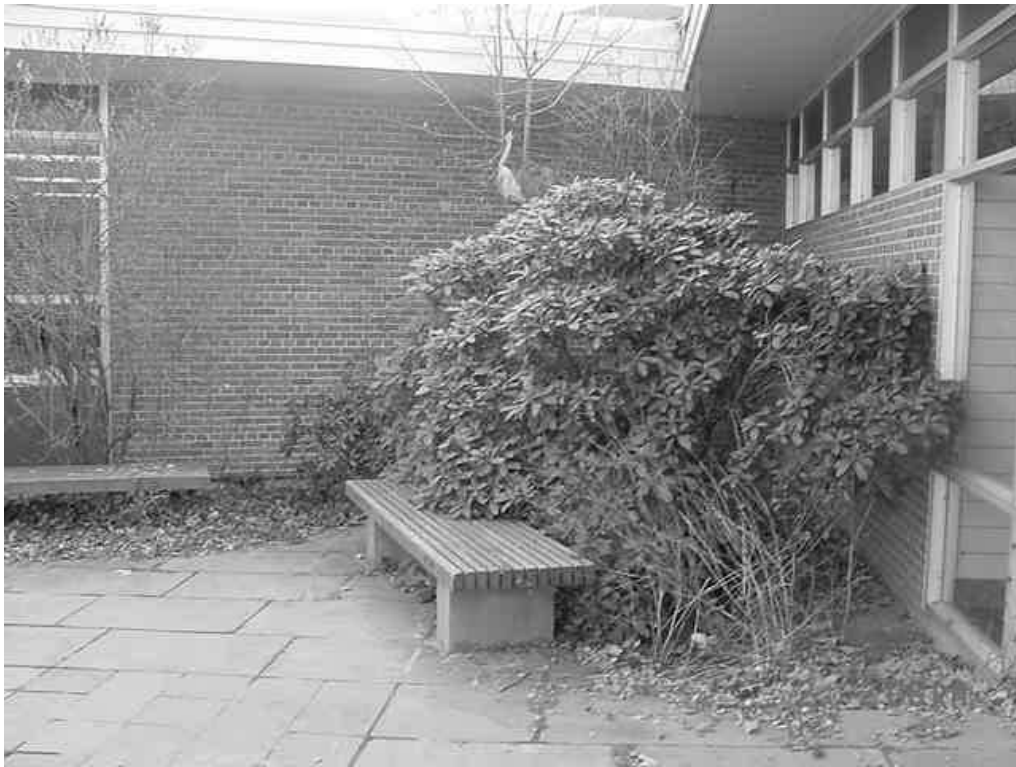
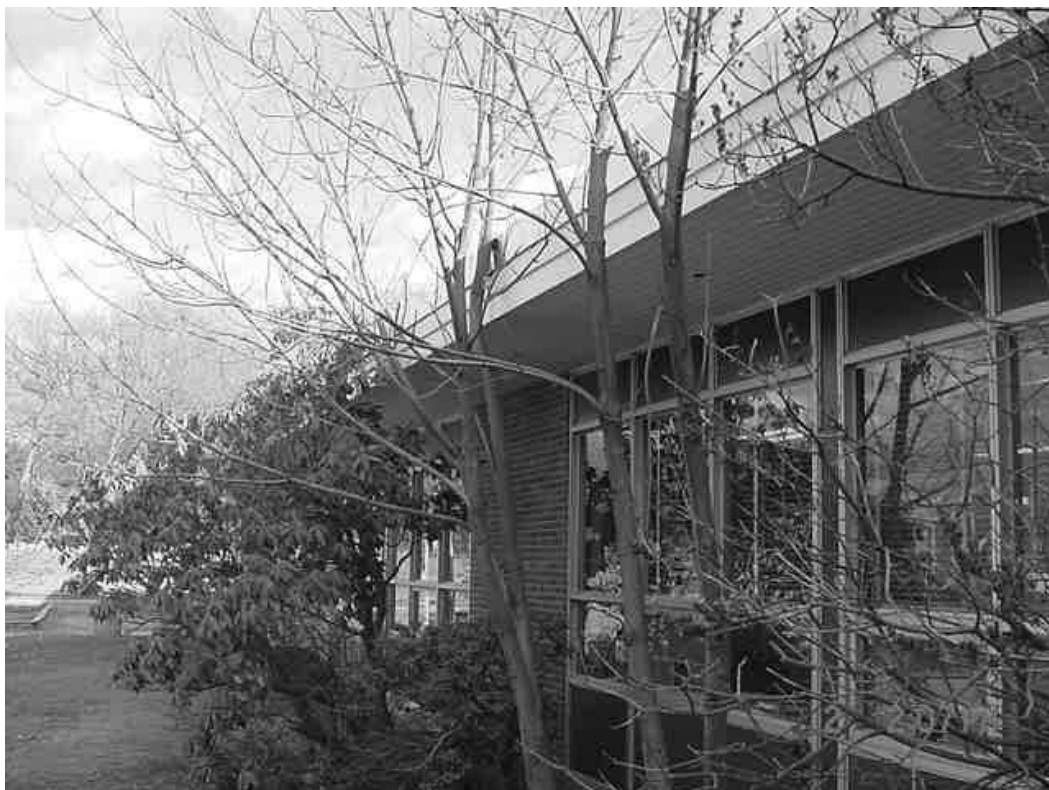
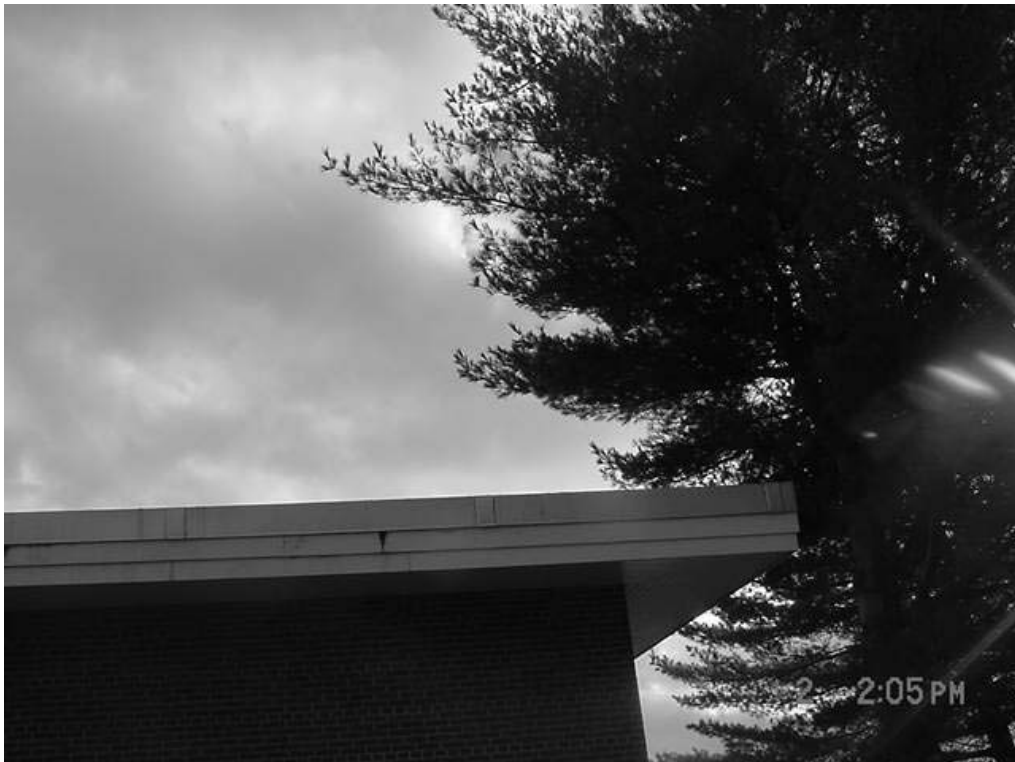
In several areas around the building, trees and shrubbery were observed growing against or in close proximity to exterior walls and over the roof (Pictures 13 through 15). The growth of plants/roots against the exterior walls and along the foundation can bring moisture in contact with wall brick and eventually lead to cracks and/or fissures in the foundation below ground level. Clinging plants inserting tendrils into brick and mortar can cause water damage to brickwork. Water can penetrate into the brick along the tendrils, which can subsequently freeze and thaw during the winter. This freezing/thawing action can weaken bricks and mortar, resulting in wall damage.

**Trees/Shrubbery Growing against Exterior Wall in Courtyard**

**Trees Growing against Exterior Wall**

**Trees Overhanging Roof**

12. Remove shrubbery away from contact with exterior walls.
13. Remove leaves and debris from subterranean pits seasonally.
14. Move plants away from univents in classrooms. Avoid over-watering and examine drip pans periodically for mold growth. Disinfect with an appropriate antimicrobial where necessary. Consider reducing the number of plants in some areas.

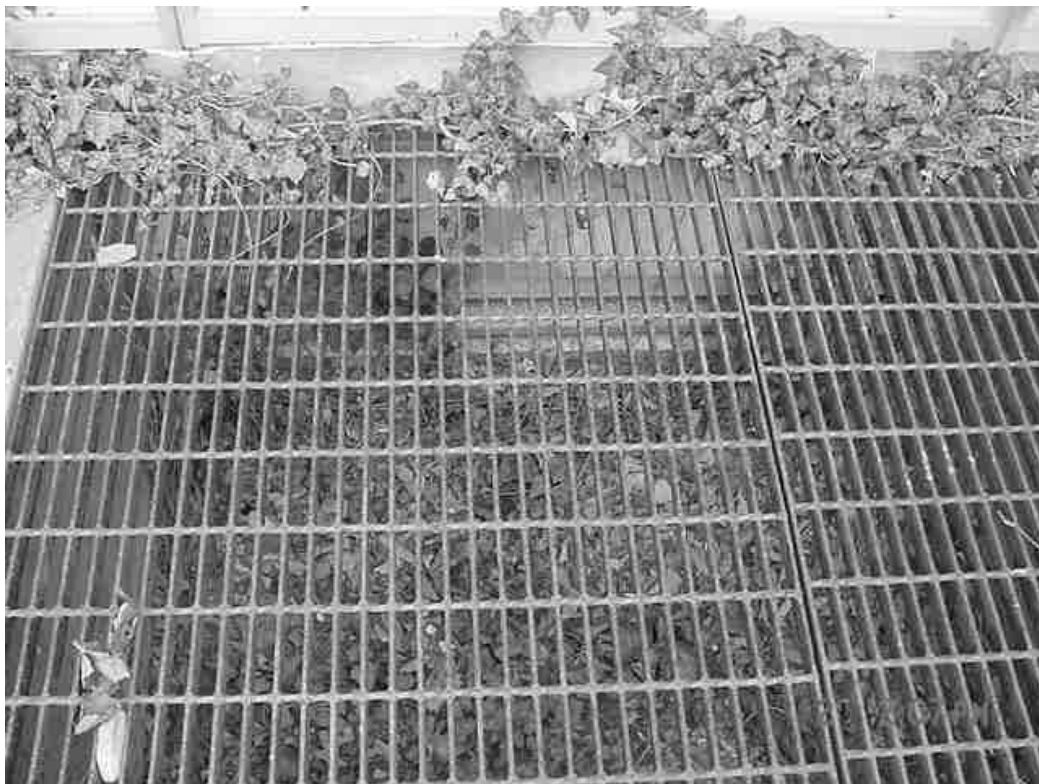
**Picture 16**

A grated subterranean pit was observed on the exterior of the building, which allows air to flow below grade into the air intake for the AHU in the basement mechanical room. Leaves,

papers and other debris were observed on the floor of these pits (Picture 16). Such debris can provide a source of mold growth and should be cleaned periodically.

**Leaves/Plant Debris in Subterranean Air Intake for Basement AHU**

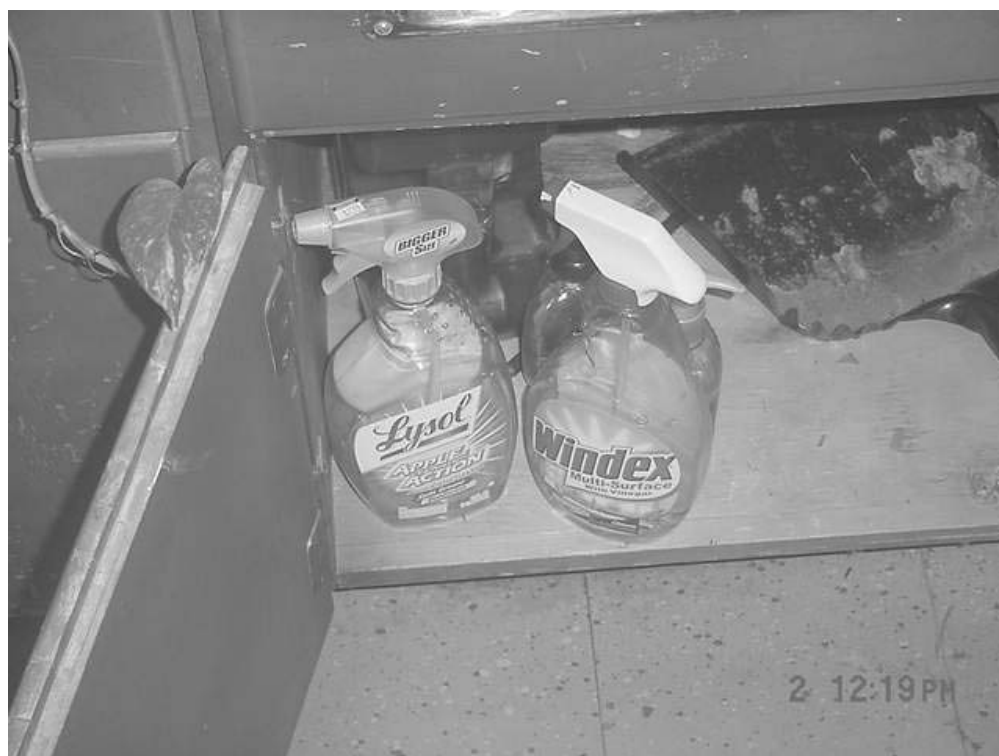
**Picture 17**

Cleaning products and other chemicals were found in floor level cabinets and on counter tops in several classrooms (Picture 17). VOC-containing cleaning products, such as bleach or ammonia-related compounds, contain chemicals that can be irritating to the eyes, nose and throat. These items should be stored properly and out of the reach of students.

**Spray Cleaning Products under Classroom Sink**

18. Store cleaning products properly and out of reach of students.
19. Refrain from hanging items from ceiling tile systems.
20. Wash stuffed toys/pillows often to prevent spread of disease and respiratory irritants.

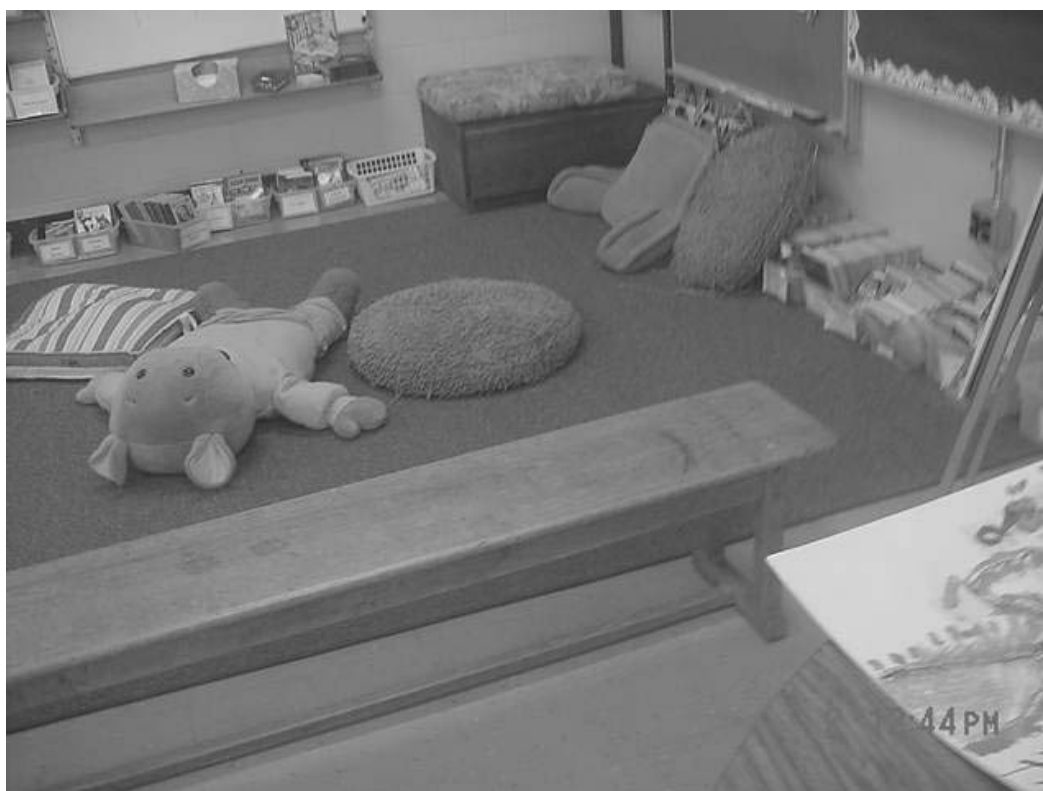
**Picture 18**

Stuffed pillows/toys were noted in some classrooms (Picture 18). Stuffed toys used by an individual child should be washed on a weekly basis (Hale and Polder, 1996). Furthermore, stuff pillows/toys can be a point for dust collection. Close contact with such items can leave oils, perspiration, hair and skin cells. Dust mites feed upon human skin cells and excrete waste

**Stuffed Toys and Pillows on Classroom Floor**

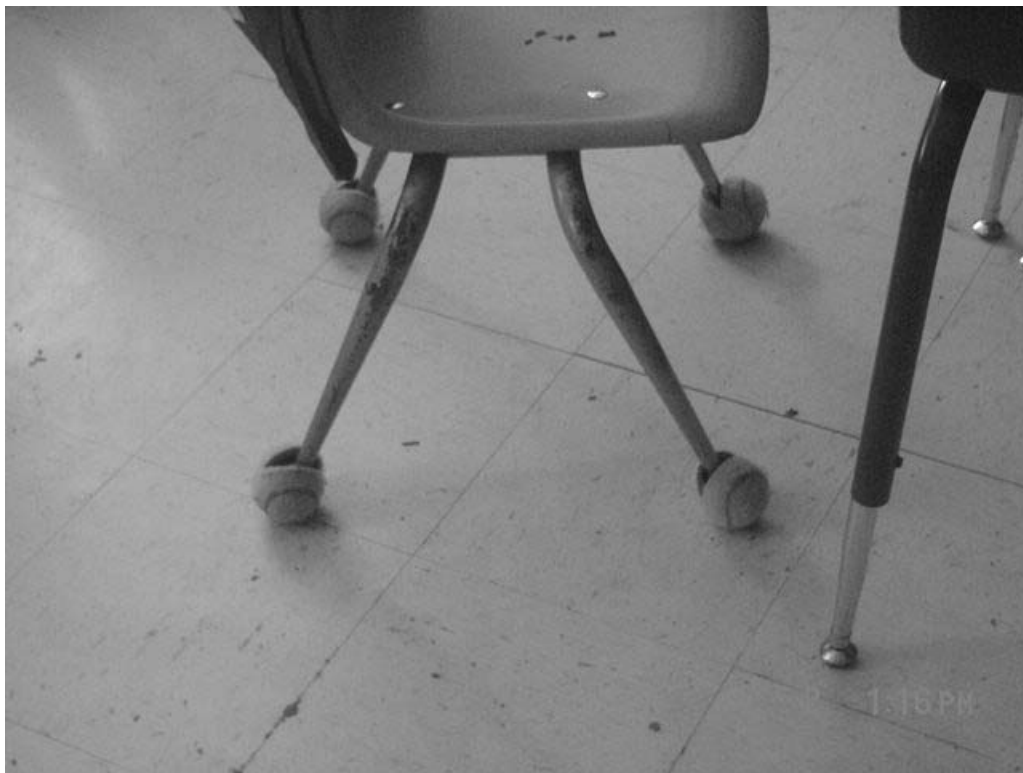
**Picture 19**

Lastly, in an effort to reduce noise from sliding chairs, tennis balls had been spliced open and placed on chair legs (Picture 19). Tennis balls are made of a number of materials that are a source of respiratory irritants. Constant wearing of tennis balls can produce fibers and off gas VOCs. Tennis balls are made with a natural rubber latex bladder, which becomes abraded when used as a chair leg pad. Use of tennis balls in this manner may introduce latex dust into the school environment. Some individuals are highly allergic to latex (e.g., spina bifida patients) (SBAA, 2001). It is recommended that the use of materials containing latex be limited in buildings to reduce the likelihood of symptoms in sensitive individuals (NIOSH, 1997). A question and answer sheet concerning latex allergy is attached as [Appendix B](#) (NIOSH, 1998b).

**Tennis Balls on Chair Legs**

21. Consider discontinuing the use of tennis balls on chair legs to prevent latex dust generation. Alternative “glides” can commonly be purchased from office supply stores (see Picture 20 for an example).
